# TREE PRESERVATION PLAN

450 McNeely Avenue

Dendron Forestry Services

December 14, 2023

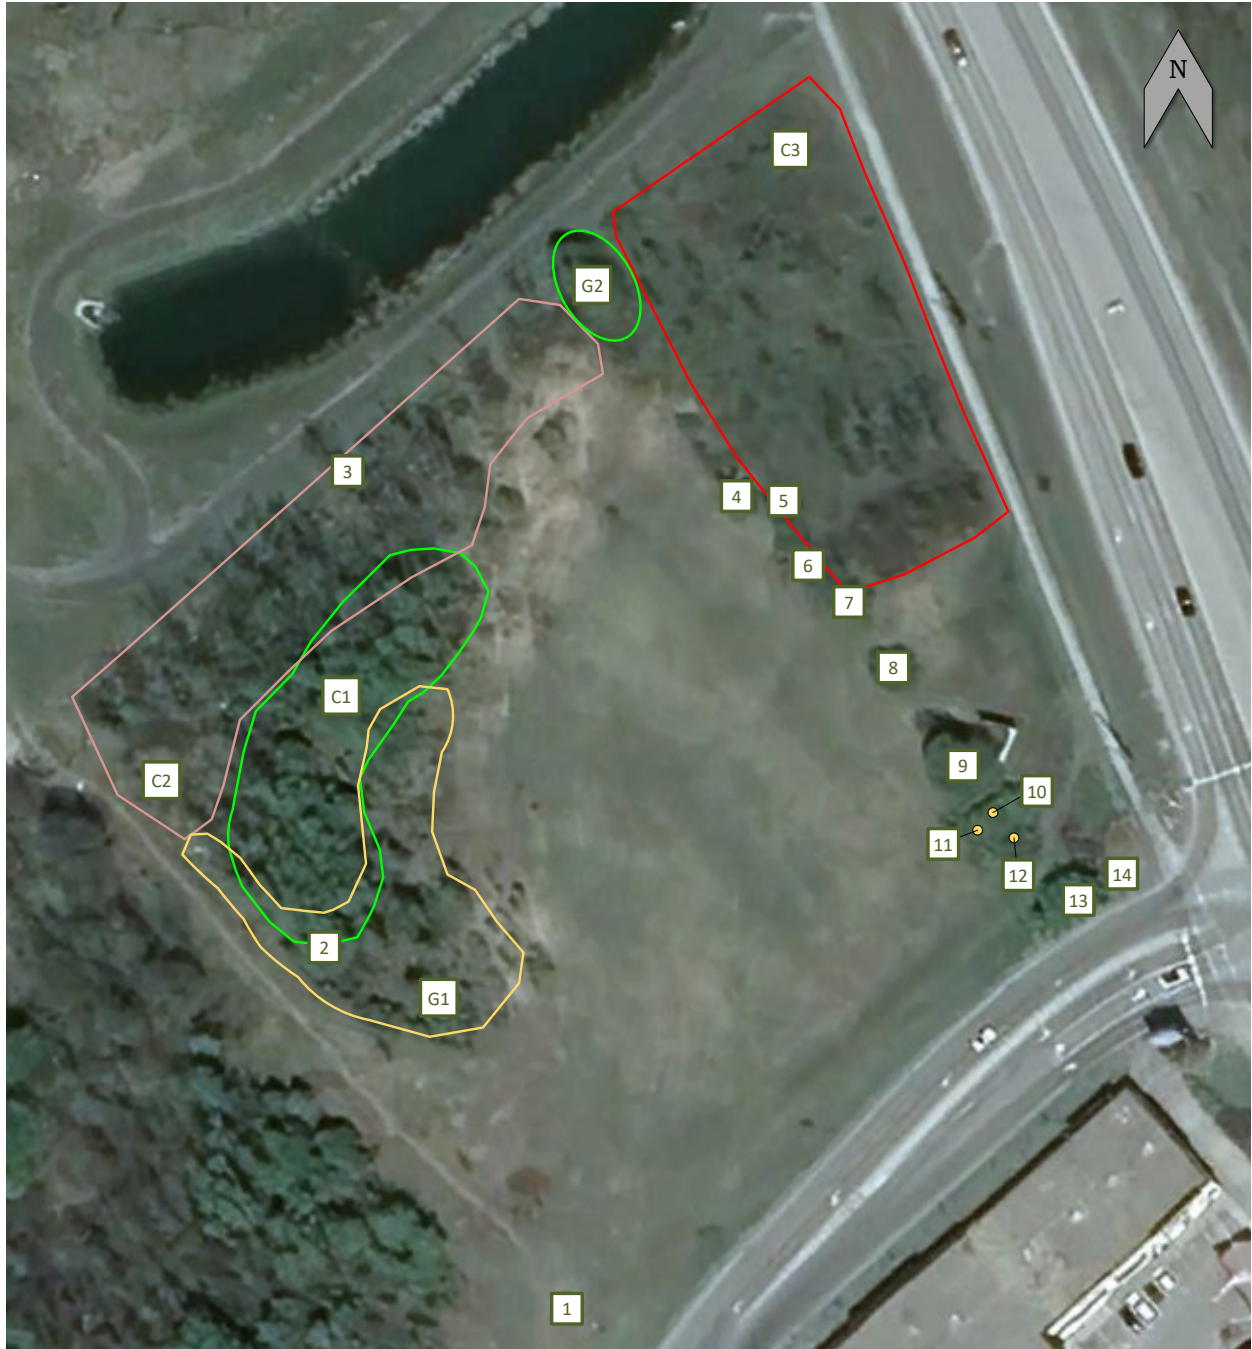
Tree Preservation Plan Map – 450 McNeely Avenue  
Tree layer prepared by  
Dendron Forestry Services  
Existing Vegetation, November 20, 2023  
For more information, please contact: [info@dendronforestry.ca](mailto:info@dendronforestry.ca)

Appendix A contains two tables: Table 1 describes individually inventoried stems >200mm DBH, and Table 2 describes groupings of trees that contain stems >200mm DBH. The trees, groupings and vegetation communities have been approximately delineated in the “Existing vegetation” map on page 3.

The site is mostly dominated by a large open grassy area. In the western corner, there is a wooded area approximately 0.5ha in size. Within this area, three distinct vegetation communities dominate: along the northwest border is an area of dead ash trees (*Fraxinus spp.*) with glossy buckthorn (*Frangula alnus* – a highly invasive shrub) growing underneath (labeled **C2**); in the center of this wooded area is a dense stand of eastern white cedar (*Thuja occidentalis*) (labeled **C1**); and at the south corner is a stand of balsam poplar (*Populus balsamifera*) (labeled **G1**). Other species noted in this wooded corner of the site are those expected in wet areas: tamarack (*Larix laricina*), common buckthorn (*Rhamnus cathartica* – also a highly invasive shrub), and red osier dogwood (*Cornus stolonifera*).

In the northern corner of the site is **C3**: a dry scrub area of dead ash trees and juniper shrubs (*Juniperis communis*).

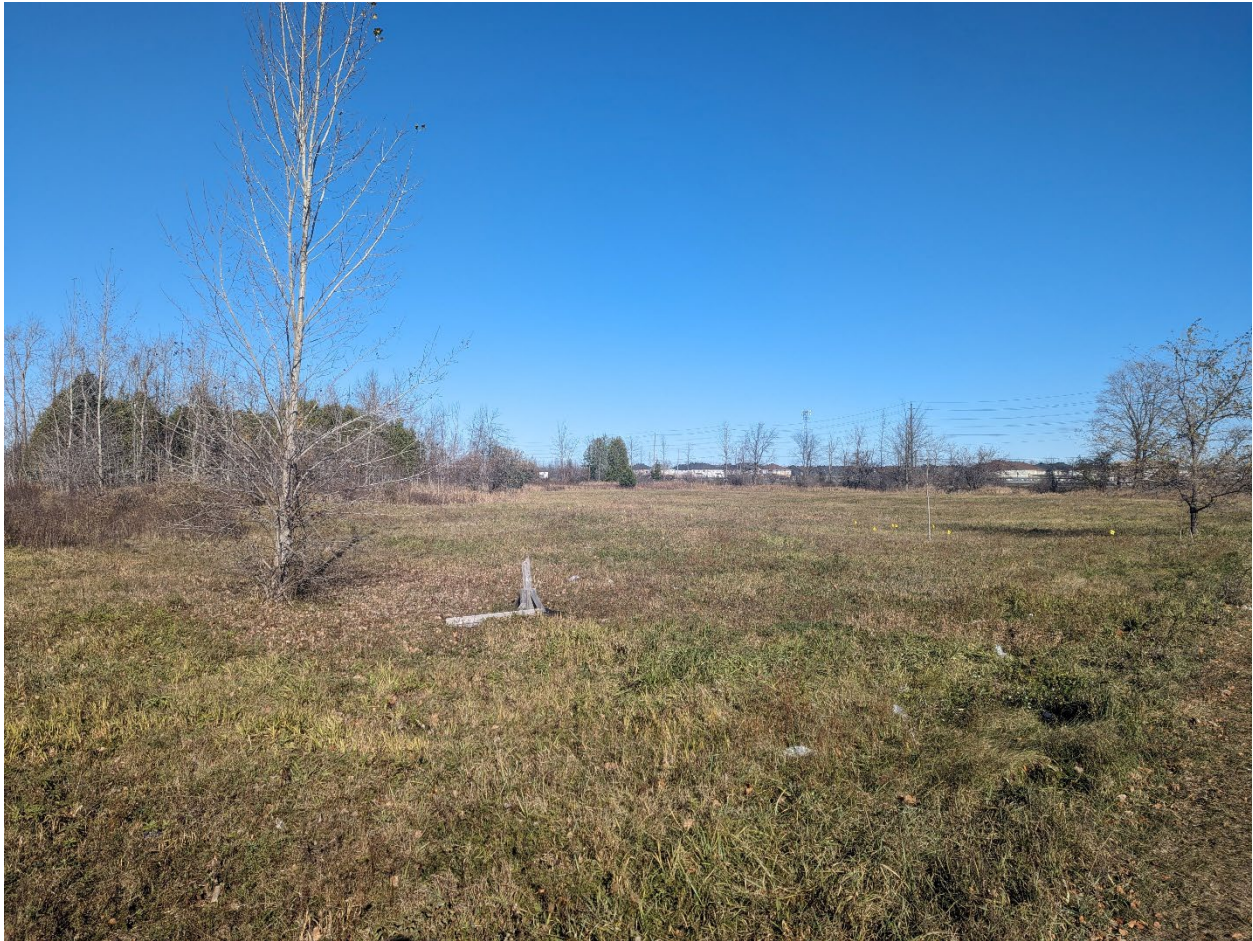
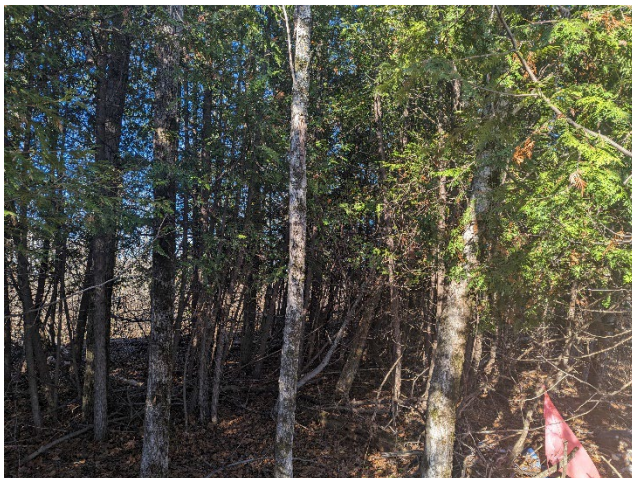
*Above: view of the site from the south corner - cedar thicket (C1) at left, Trees 4-11 in background. Below: small cedar and poplar stems in the cedar thicket*

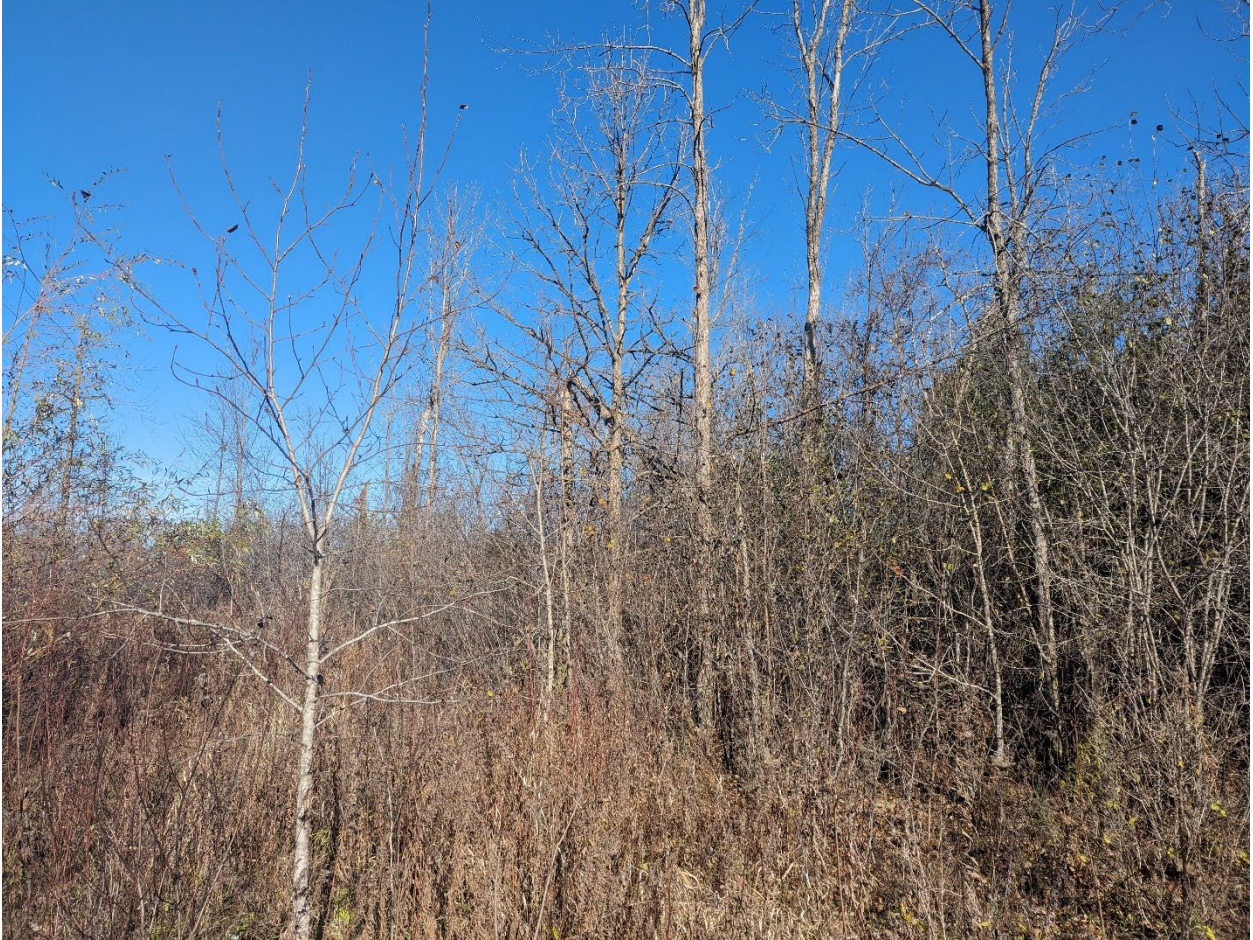
*View of the property from the west corner. Looking into C2 - dead ash and glossy buckthorn*

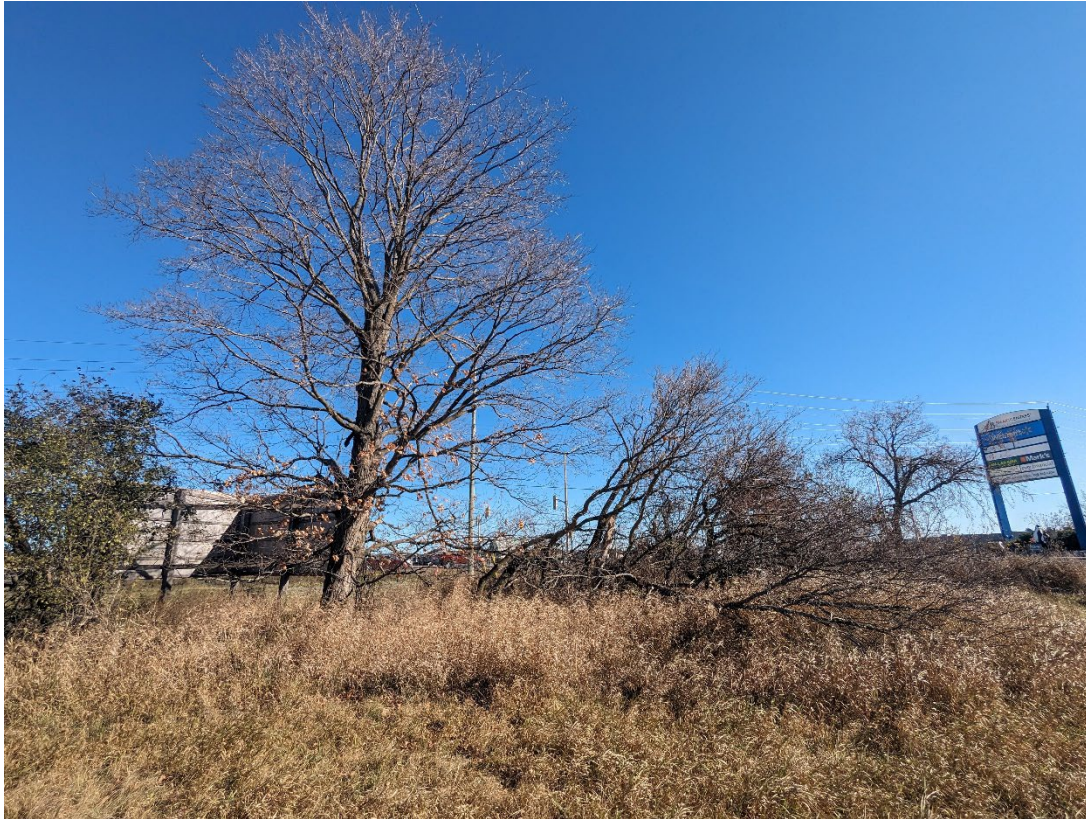
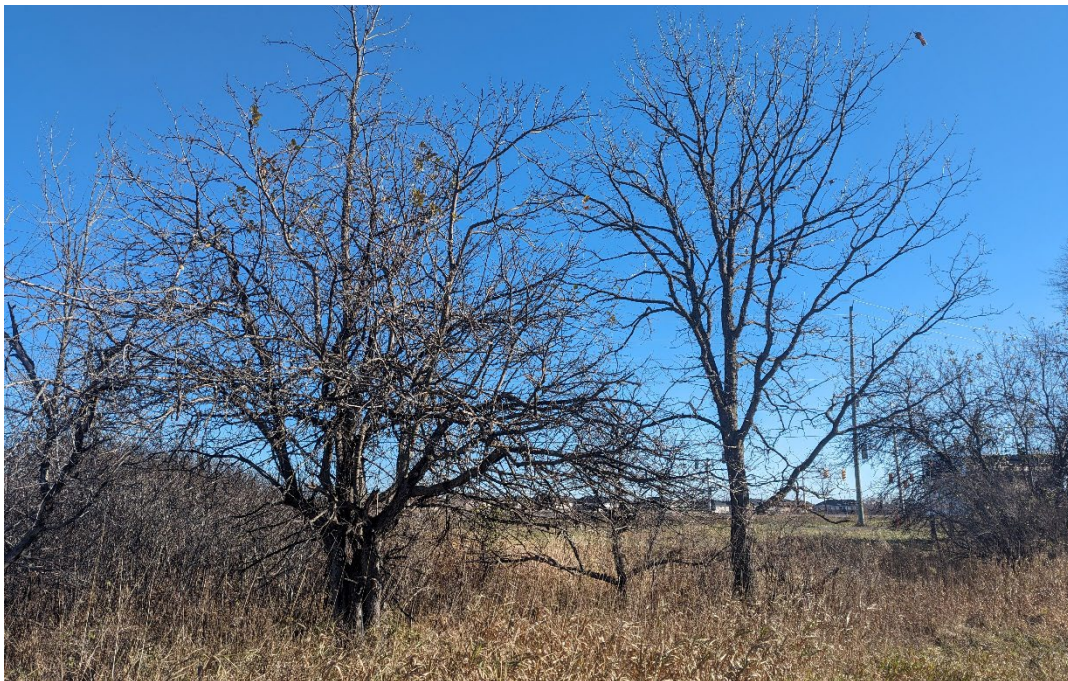
10	Manitoba maple ( <i>Acer negundo</i> )	25, 15, 12	Poor – growing horizontally		Remove due to proposed plans
11	Manitoba maple ( <i>Acer negundo</i> )	26, 23	Poor – growing horizontally		Remove due to proposed plans
12	Apple ( <i>Malus spp.</i> )	23, 25, 13, 13, 14	Fair/Poor – many dead branches; poor form	13	Remove due to proposed plans
13	Manitoba maple ( <i>Acer negundo</i> )	38, 20	Fair/Poor – large branch attachment wound; lean towards subject property	14	Remove due to proposed plans
14	Red oak ( <i>Quercus rubra</i> )	14	Good	6	Below 200mm caliper. Protect with fencing during Phase E.

*Above: Trees 9 (sugar maple at left), 10 and 11 (maples growing horizontally at right).*

*Below: Tree 6 (left) and Tree 7 (right)*

Due to the proposed development, tree preservation will be very difficult. Due to the proposed building and parking, as well as the need for a below grade electrical duct bank and visual clearance for the retail signage, **Trees 1-13** are recommended for removal at this time.

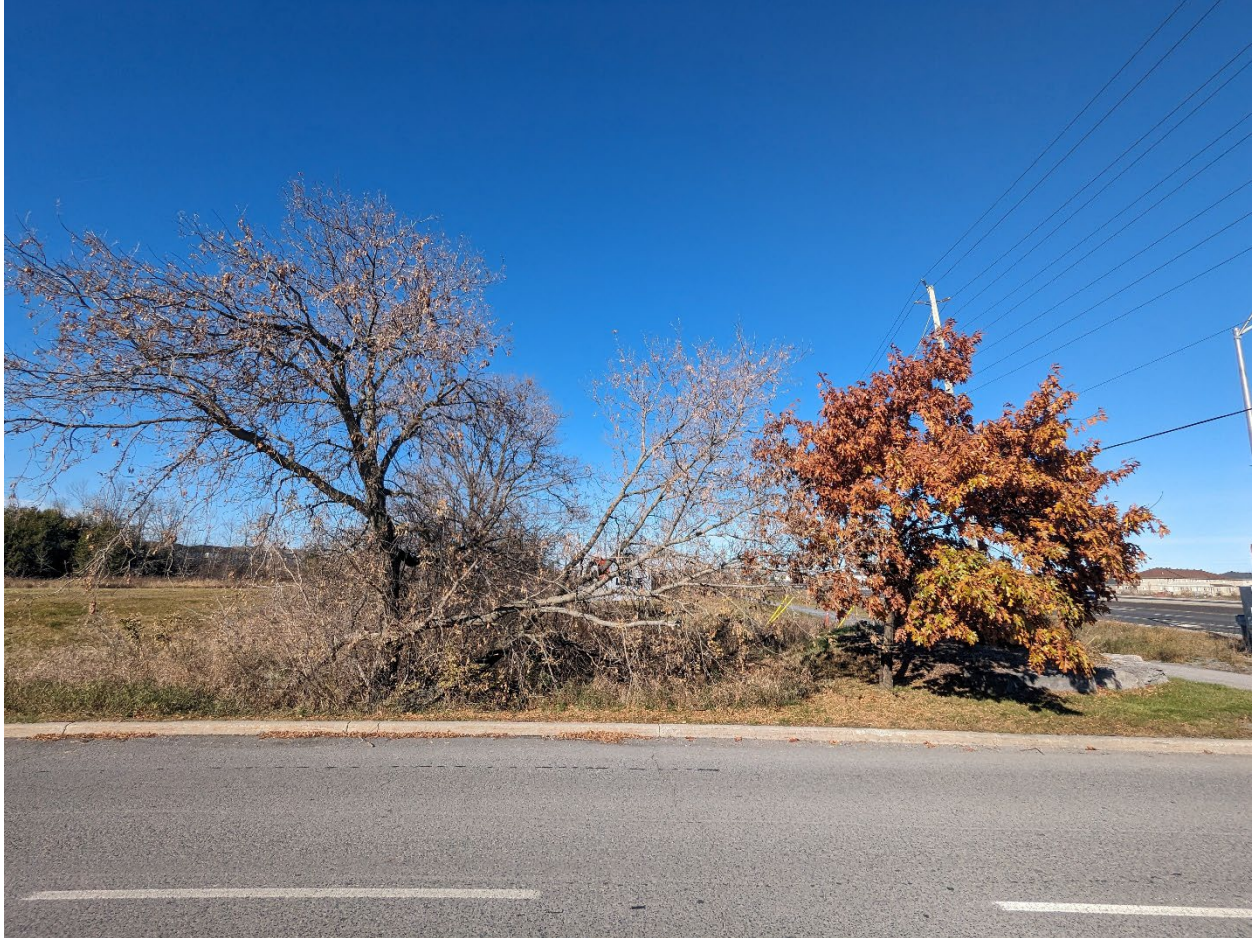
*Tree 13 (left) and 14 (right). Tree 14 should be protected with fencing during construction*

While it does not meet the 200mm caliper threshold for protection, **Tree 14** is in good condition and is at a higher grade than much of the existing site. During Phase 1, provided this corner does not require regrading or it is not in conflict with the design, Tree 14 may be retainable.

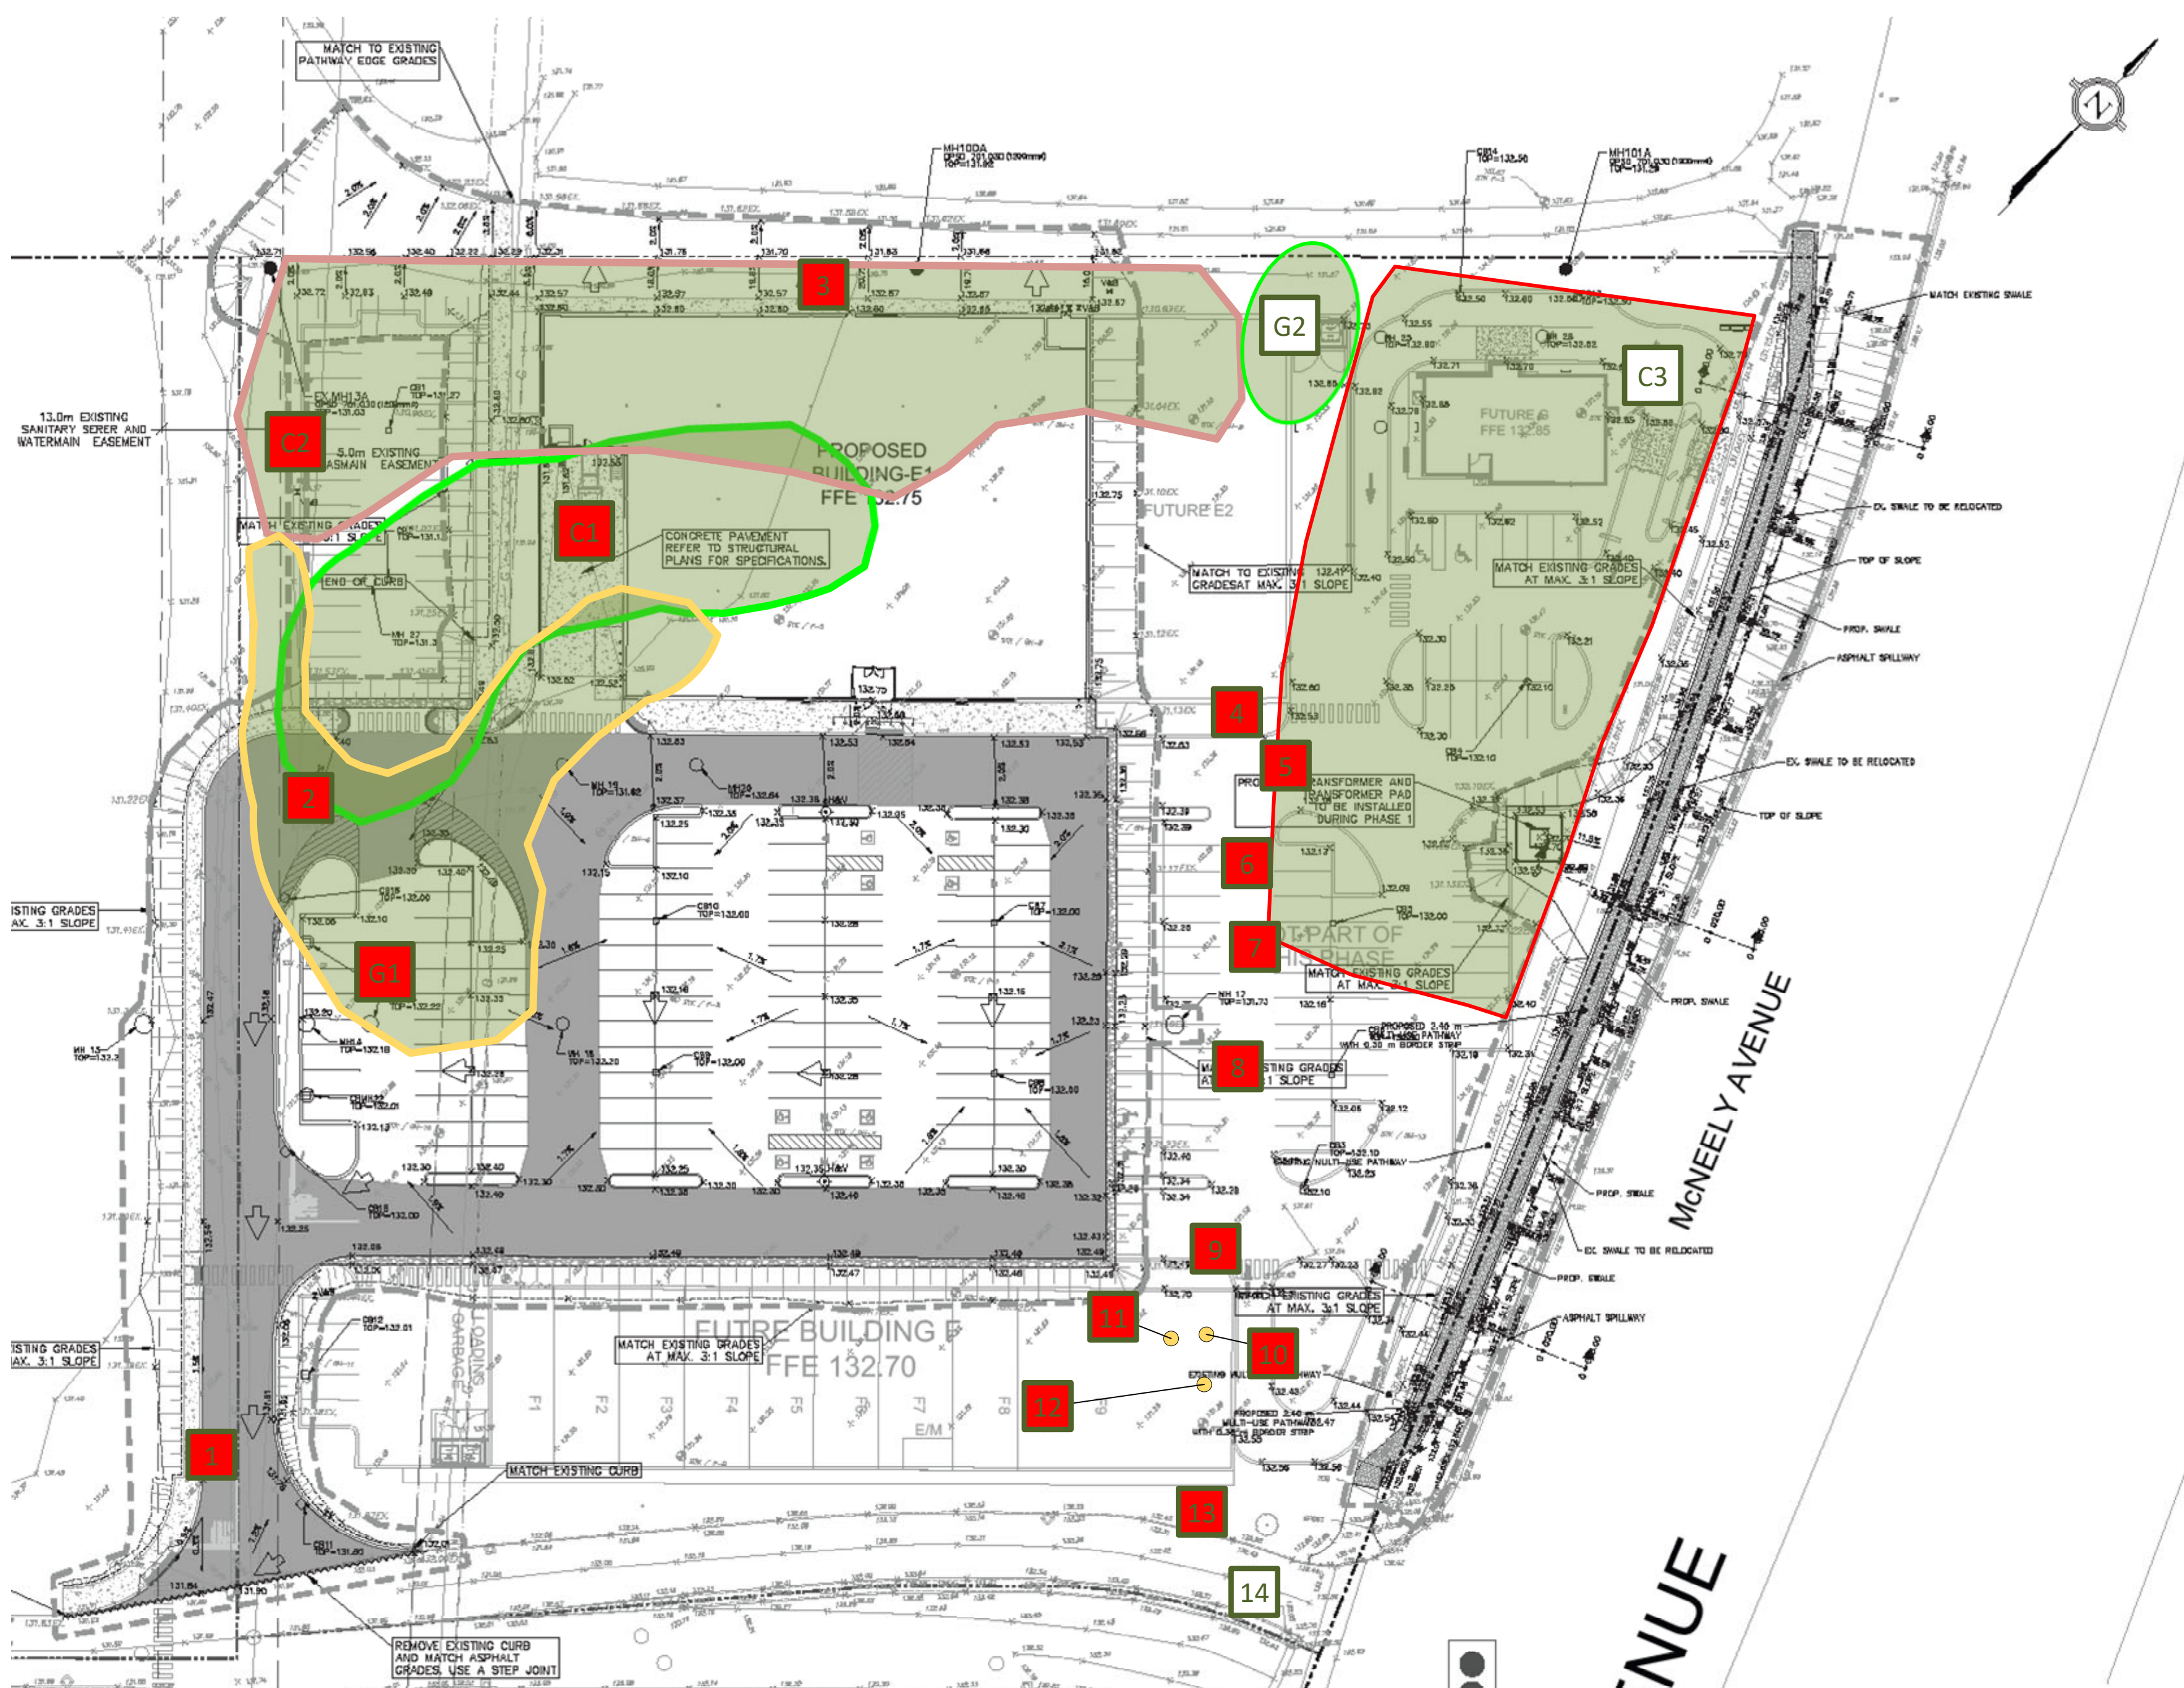
Tree Preservation Plan Map – 450 McNeely Avenue  
 Tree layer prepared by  
 Dendron Forestry Services  
 Proposed development and tree removal, December 14, 2023  
 For more information, please contact: info@dendronforestry.ca

Vegetation Community	Description	Forester recommendation
C1	Dense cedar thicket	Remove due to proposed plans
C2	Dead ash undergrown with glossy buckthorn	Remove due to proposed plans
C3	Dead ash and elm trees scattered among juniper bushes.	Remove lower portion to accommodate required electrical duct bank and site works. Retain upper portion during Phase 1 to control erosion and provide food and shelter for fauna.

Group **G2**, the cedars near the northern boundary of the property, can be retained during Phase 1. They will likely need to be removed for the next phase when it occurs. Similarly, a portion of **C3** can be retained during Phase 1. The dead trees in C3 should be cut down for worker safety and for aesthetic reasons.
